Manhole Inspection Summary

Manhole # S37EE_027MH

Insp Date: **3/22/07 8:40 AM**

Location Address: **1218 BRENTWOOD AVE**

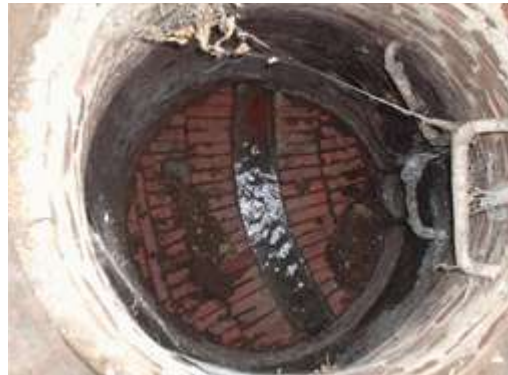
Top View

Bench ☒ Exists Material: **Brick** ☐ Parged ☒ **Debris** (not Condition related)

Channel Material: **Brick** ☐ Parged ☒ **Debris** (not Condition related)

Steps Count: **5** Missing: **0** ☒ **Corroded**

Surcharge ☒ **Evidence Of Surcharge** Depth: **4** (ft.) ☐ Active Surcharge Present

Evidence of surcharge - Bench debris.
Corroded steps. Channel debris.

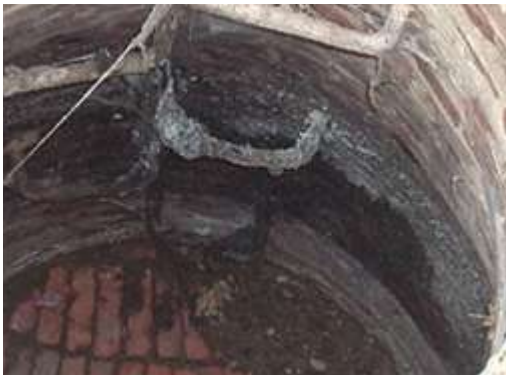
Defect

Infiltration: ☐ None ☐ Joint ☐ Cracks ☐ Mortar ☐ Roots ☒ **Wall**

Barrel infiltration.

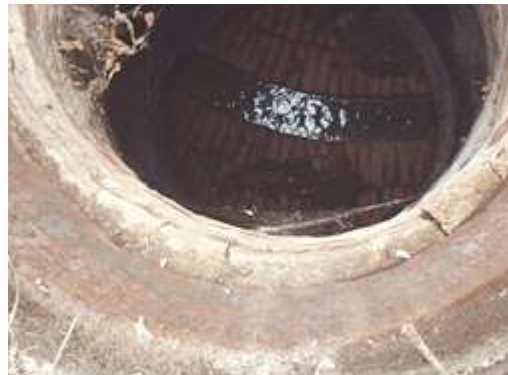
Defect

Frame Offset: **2** (in.) Condition: ☒ Sound ☐ Cracked ☐ Leaks

Frame offset.

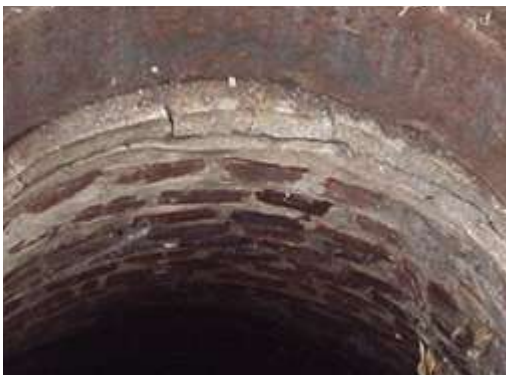
Defect

Condition: ☐ Sound ☒ **Cracked** ☐ Root Intrusion ☐ Loose Brick ☐ Deteriorated

Infiltration: ☐ None ☒ **Joint** ☒ **Cracks** ☐ Mortar ☐ Roots ☒ **Wall**

Adjustment cracks and infiltration.

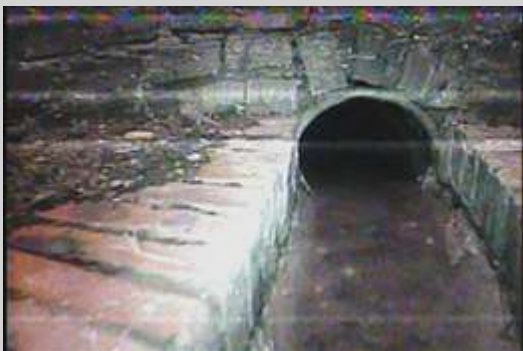
8 in. Circular Gravity Sewer Pipe In @ 5 O'Clock

Condition: ☐ Sound ☐ Cracked ☐ Root Intrusion ☒ **Deteriorated** ☐ Leaks ☐ Debris

Channel deterioration.

Deposits: ☐ None ☒ **Mud** ☐ Sludge ☒ **Debris** ☐ Grease

Infiltration: **None** Pipe Seal Cond: **Broken**
